INSURANCE SURVEY **REPORT**

SPACESAILER YACHT **“SHIRALEE”**

13/9/2019

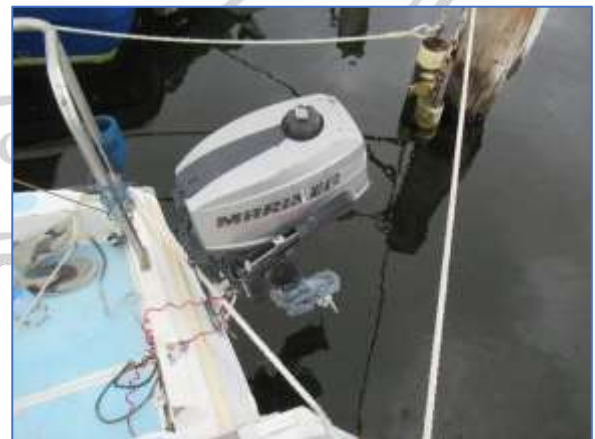
ENGINE

- The engine is a 'Mariner' 5hp long shaft outboard.
MODEL: ME5NL
SERIAL: TA43187
YEAR: 2012
- The engine is mounted on a stainless-steel hinging bracket on the starboard side of the transom. Secure.
- No fuel tank was sighted.
- This vessel is tiller steered. The tiller is 48mm teak timber in reasonable condition. A 6mm stainless-steel hinging cap fitting secures the tiller to the rudder. A tiller extension is fitted.

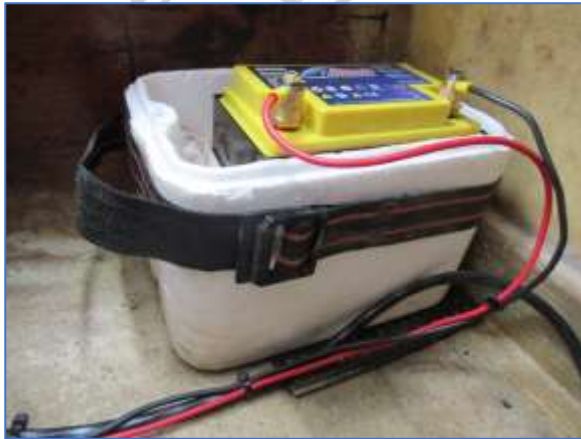
BATTERY STORAGE

1. 'Full river' HC14A 200CCA 20RC 14ah.
 - The battery is fitted in a foam box and secured with a webbing strap.
 - The cables to the batteries and connections are in good condition.

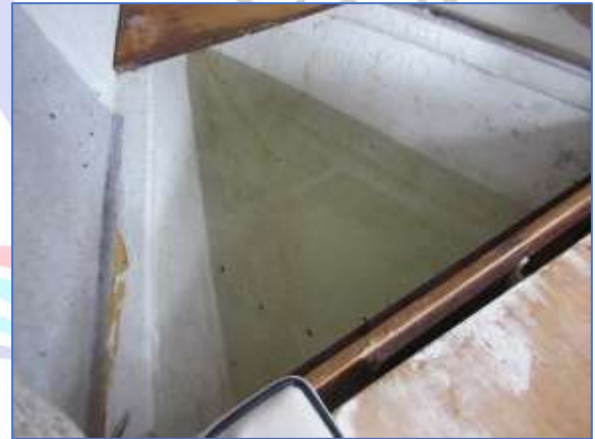
WATER IN FORWARD LOCKER

7	B	There is a significant amount of water being held in the forward locker under the 'V' berth.	Remove.
---	---	--	---------

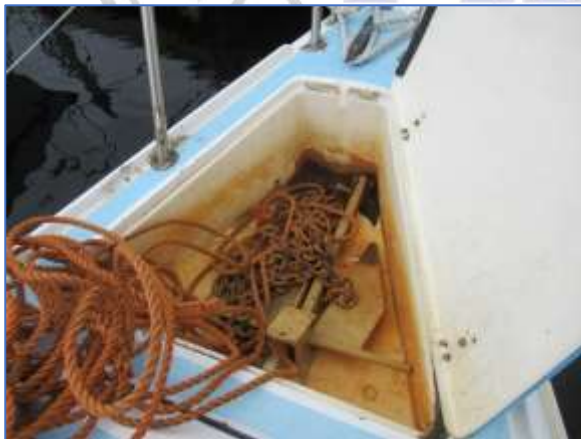
GROUND TACKLE

9	B	The anchor chain is quite corroded.	Replace.
10	B	The flares are out of date.	Replace.

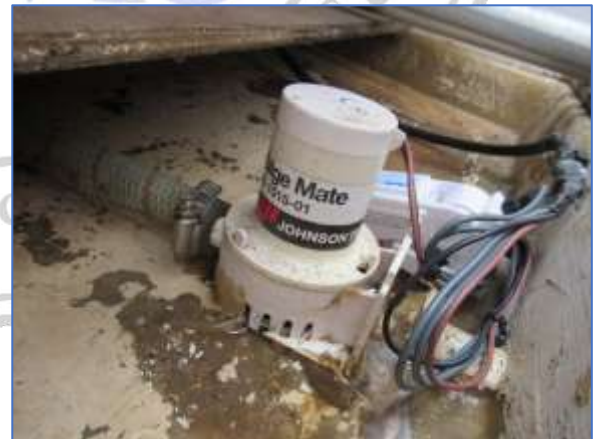
BILGE PUMP

- The hose tails are plastic.
 - The hose clamps are stainless-steel.
 - The hoses are predominantly clear plastic or NTP hose.
 - 1 x 'Johnson' 12-1015-01 submersible bilge pump is fitted in the aft bilge. This has a 'Rule-a-matic' float switch fitted for activation. Tested and working.
