INSURANCE SURVEY **REPORT**

SPACESAILER YACHT **“SHIRALEE”**

13/9/2019

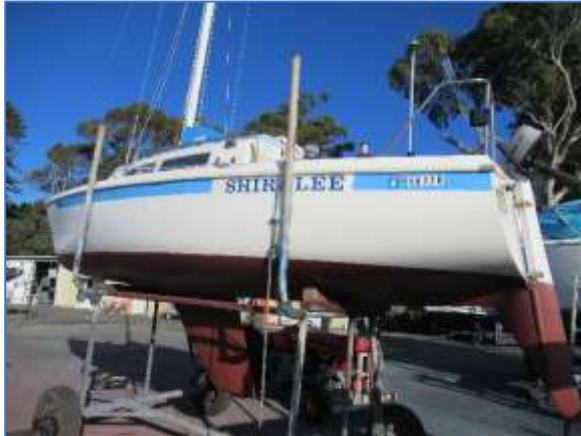
PORT SIDE

Note: Generally, the topsides are in reasonable condition. Some gelcoat stress cracks, chips and scars and previous repairs were sighted.

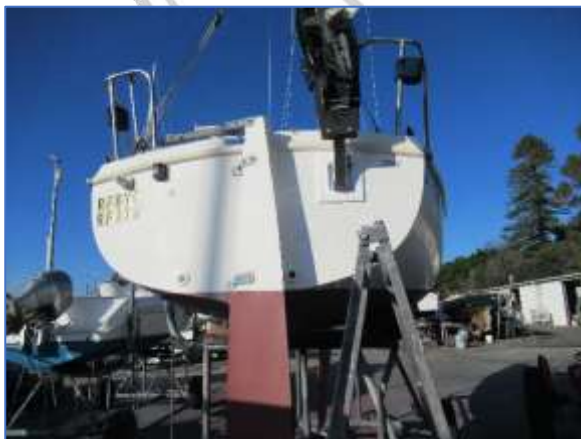
TRANSOM

- The rudder blade is constructed of a fibreglass skin in 2 halves that are bonded together. 350mm x 1000mm. This is secured on 2 x 5mm stainless-steel gudgeons bolted to the transom. The pintles are also 5mm stainless-steel in good condition and both securely bolted. Blade area .350m². There is considerable movement between the gudgeons and pintles.
